Residual contamination and environmental effects at the former site of Vanda Station, Antarctica

***WCFM Report 2016-004
(event K081-1415-B)***

TITLE: **Residual contamination and environmental effects at the former site of Vanda Station, Antarctica.**

DATE: **20 December 2016**

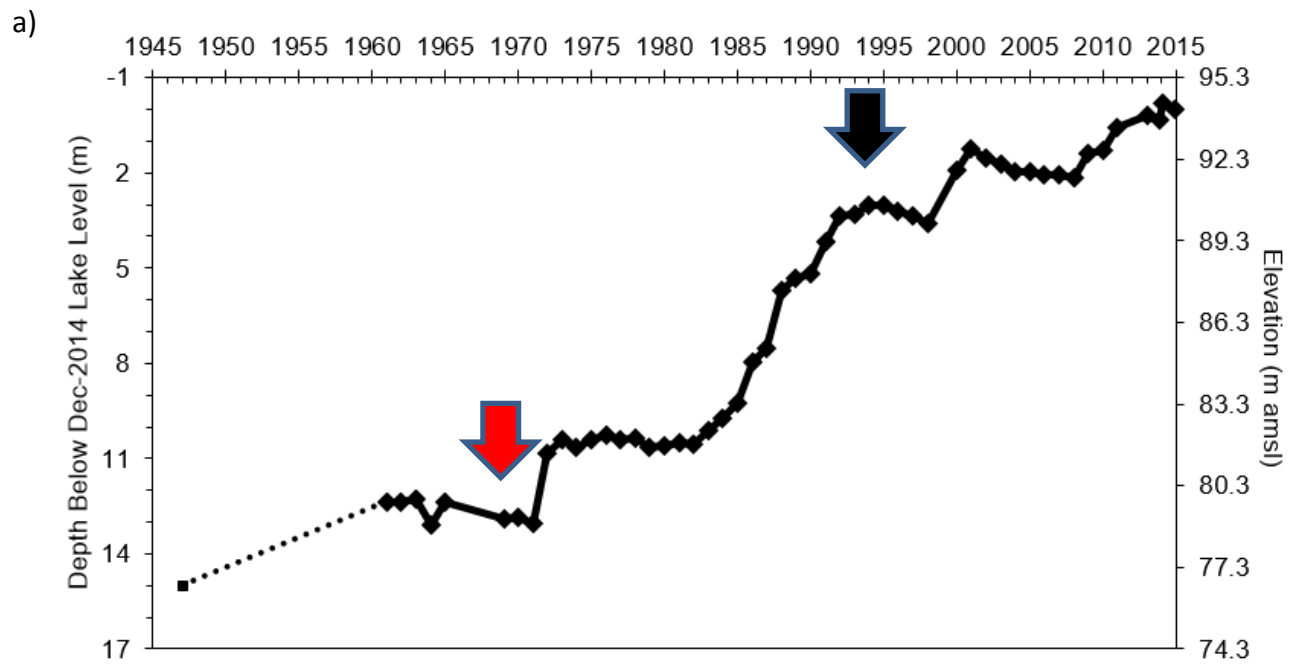
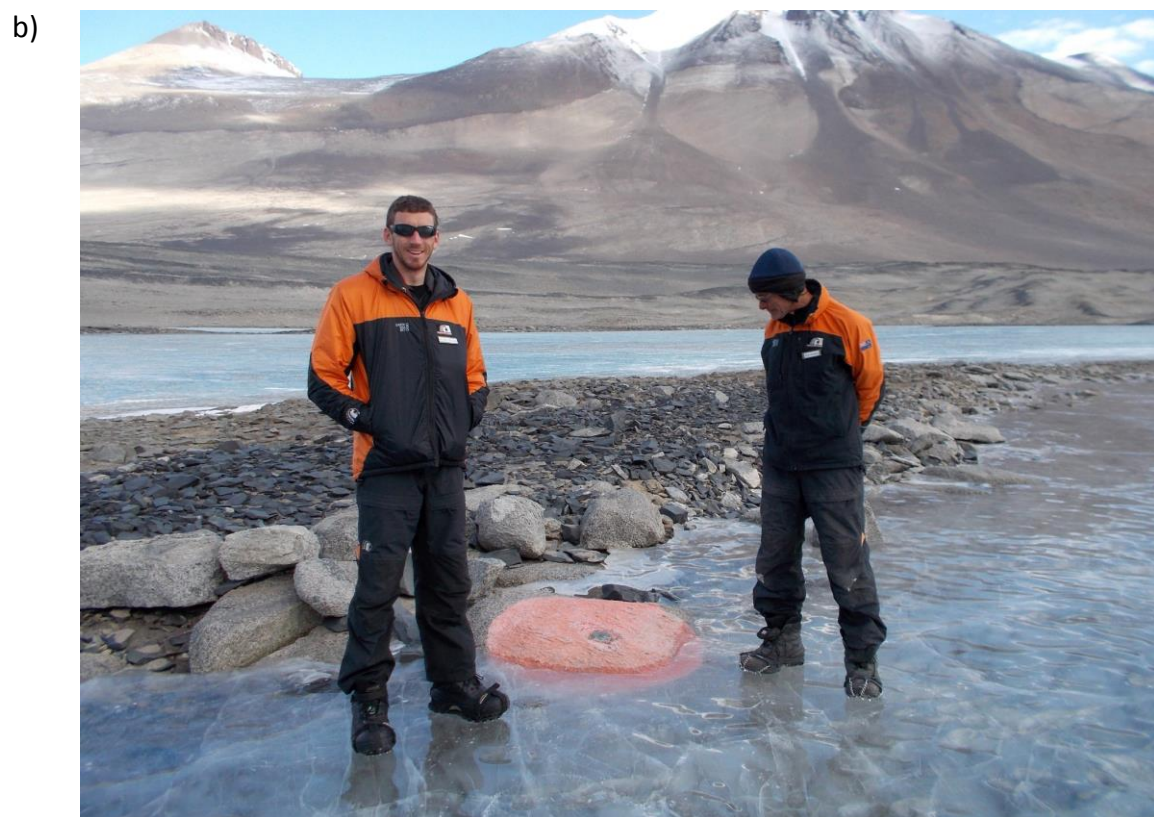
Figure 2. a) The level of Lake Vanda recorded from the “Astro A” benchmark from 1961-2014, with a value for 1947 derived from aerial imagery (modified from Castendyk et al., 2016). Red and black arrows indicate the building and decommissioning of the station. **b)** The “Astro A” benchmark in December 2014, now at water level, with Peter Taylor (L) and Ian Hawes (R).

Lake Vanda is a closed basin lake (i.e. it has no outlet) and its level is set by the balance of inflowing water from the Onyx River and ablation from the perennial ice surface (Chinn, 1993). Hydrological monitoring since 1969 has indicated that the lake's level has been, and still is, rising (Chinn, 1993; Green & Lyons, 2009), as shown in Figure 2. A decision to decommission and dismantle the station was made in 1993, due to the risk of flooding and a change in NZ's scientific focus in the Dry Valleys. The decommissioning process was comprehensive in its attempts remove contaminants and restore the area to a natural state (Hayward et al., 1994; Waterhouse, 1997). The process included:

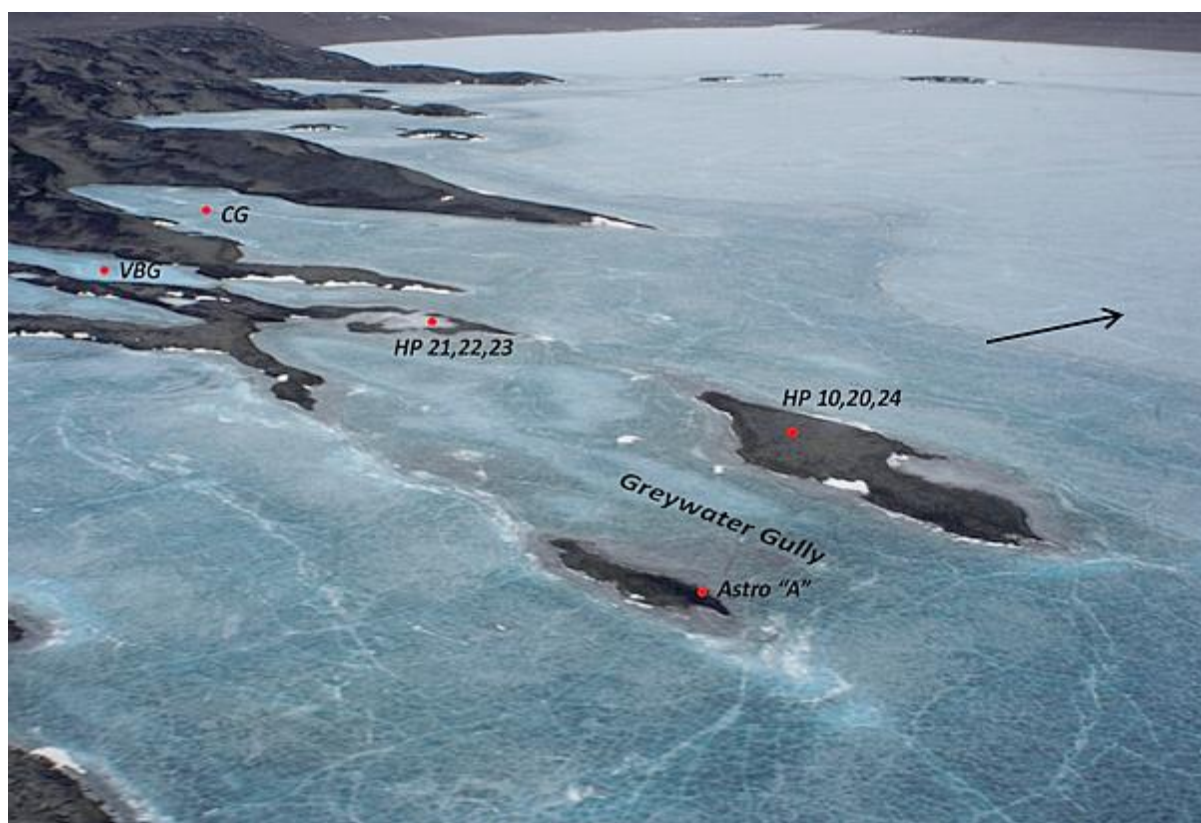
Figure 3. Aerial view of the location of the former site of Vanda Station (larger island) looking west along the lake (arrow indicates north). Sampling locations are shown approximately for perspective only. Refer Appendix 1 for an aerial image of the former station in the early 1980s.

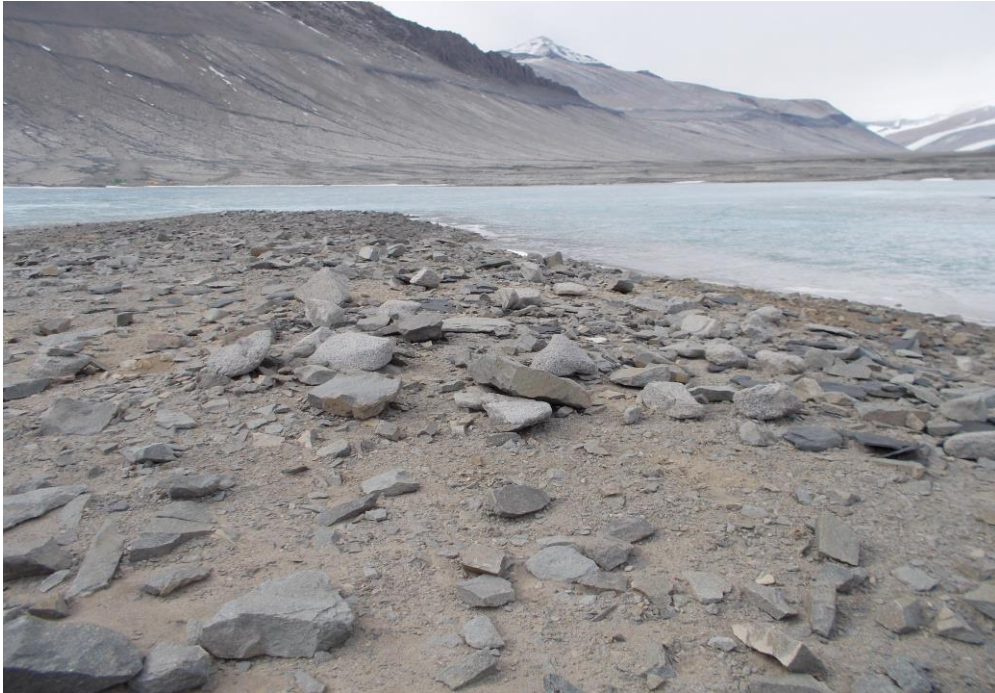
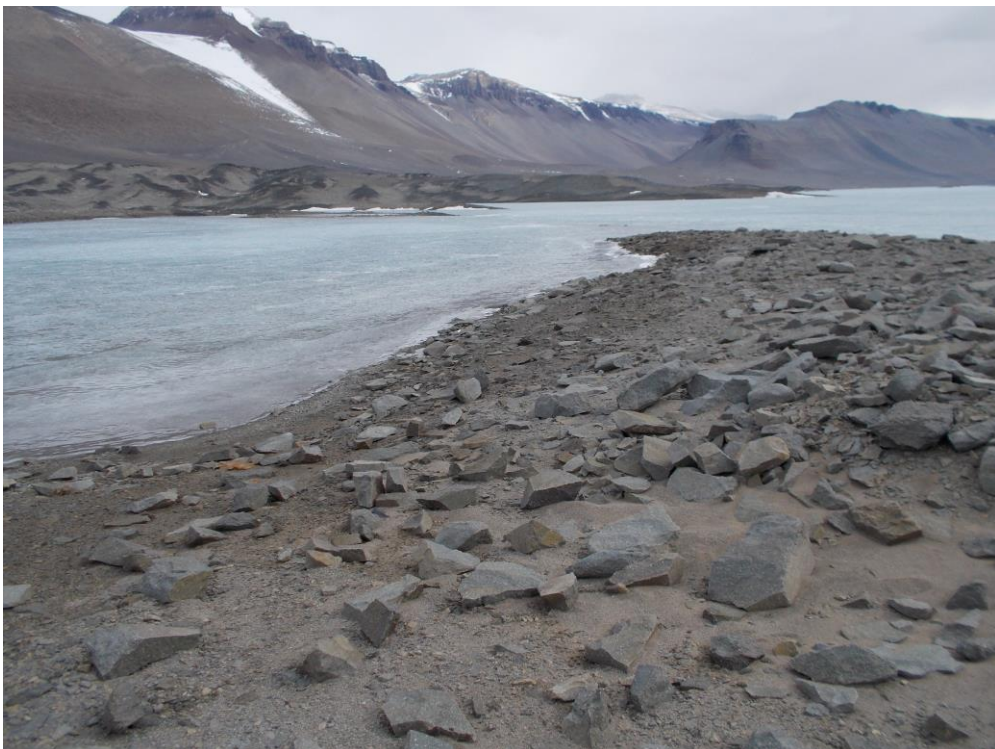
Figure 4. a) View looking east across old station site, standing at the edge of the old mess building site, **b)** View looking west from old station site (standing at the edge of the old mess building site), towards the main helicopter pads (partly flooded).

Site selection, sampling and analysis followed the approach taken in the previous studies (Hawes et al., 1999; Webster et al., 2003) to allow for direct comparison of results. However, when this previous contaminant assessment was done at the Vanda Station site, the lake level was approximately 3m below present, and all sites sampled were either above the water line, or in very shallow water. When revisited in December 2014, Greywater Gully sites were under approximately 3-4m of lake water and ice (Figure 3), and the main helicopter pads were under 0.1-0.2m of water (Figure 4a & b).

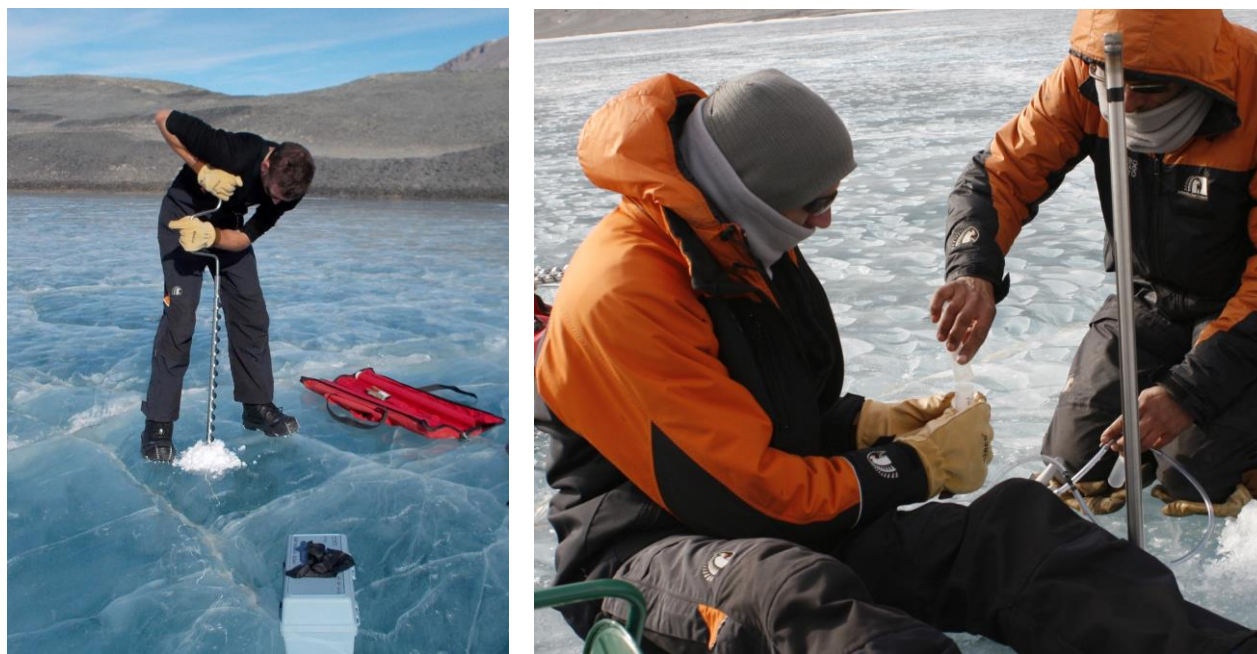
Figure 6. Drilling with a Kovac ice auger in Greywater Gully (L) and sampling the water column beneath the ice using a suction system (R).

All flooded sites, except HP21, 22, 23, were covered with ca. 2.0m of ice. Once located, the ice cap was drilled using a hand-operated Kovac auger taking care not to allow any ice to fall back in the hole (Figure 6). GPS coordinates were taken at each location, and the ice thickness and bathymetry was determined using a modified weighted measuring tape. Bathymetry measurements included both the total depth and piezometric level (depth to water level in ice hole). Using a specifically designed water and pore water sampling suction system, water samples were collected from immediately below ice cover (surface), midway, and at the base of the water column. The sampling system comprised of a rigid aluminium pole with PVC tubing running to a sealed sampling chamber at the base to allow discrete sampling at specific depths (Figure 6). Water samples were drawn through the tubing using a hand operated suction pump.

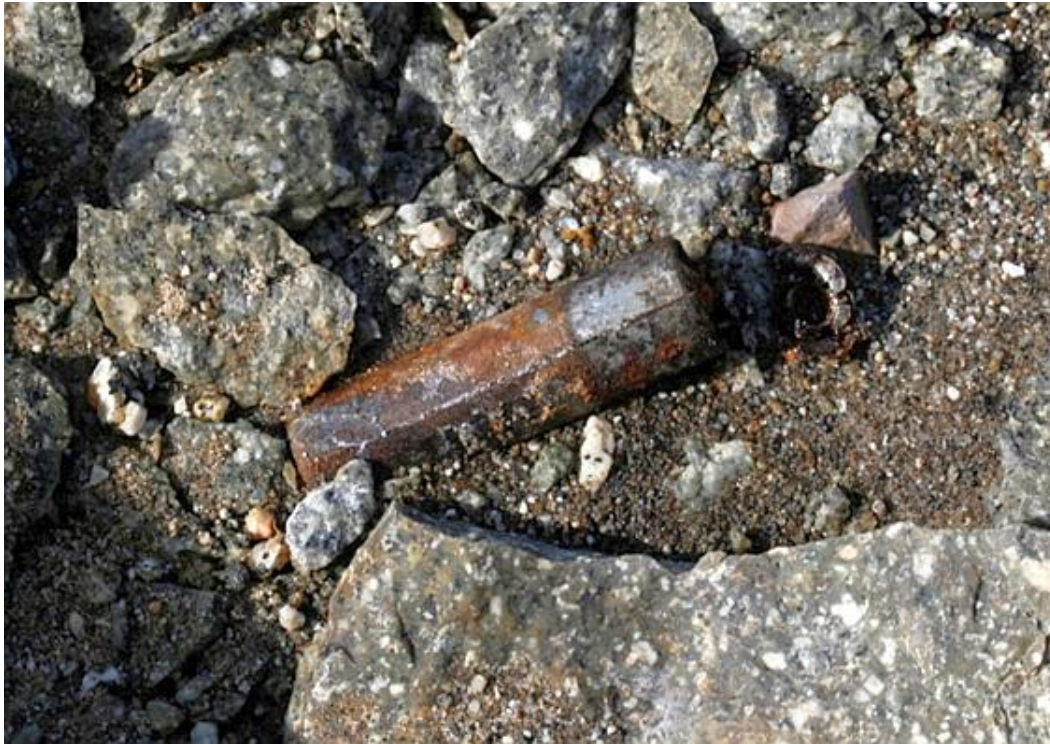
Figure 7a. A battery found in the soil at the former Vanda Station site, located approximately 0.15m above lake level.

During field work approximately 500g of rubbish and building debris was collected from the soils, despite the fact we were not actively seeking or collecting such debris. Debris included nails, batteries (Figure 7a), paint flecks, wood chips, and plastic. Other physical contaminants in the soils include the orange painted rocks used for both Astro A (survey point, Figure 2b) and marking out the helipads (Figure 7b). Some of the painted rocks have been repositioned from the former station site to the new Vanda Huts, to mark out the current helipad.

Soils were sampled neither extensively nor randomly on the area of Vanda Station's footprint still above lake level. Instead likely problem areas such as helicopter pads and fuel spill sites (as identified in previous surveys) were targeted. Hydrocarbon contamination (TPH) of the soil in known problems areas was still high, with the residual contaminants being mainly the long chain, less volatile hydrocarbons which persist in this environment. Elevated concentrations were still evident at 30-50cm depth at one of the spill sites. Of the trace elements tested, only Pb and Zn were particularly elevated, and mainly in the hydrocarbon-enriched soils. Pb was also high in some of the recently flooded helicopter pad sediments, near where metal-detritus and the Pb-based red paint had been observed (Figure 7).

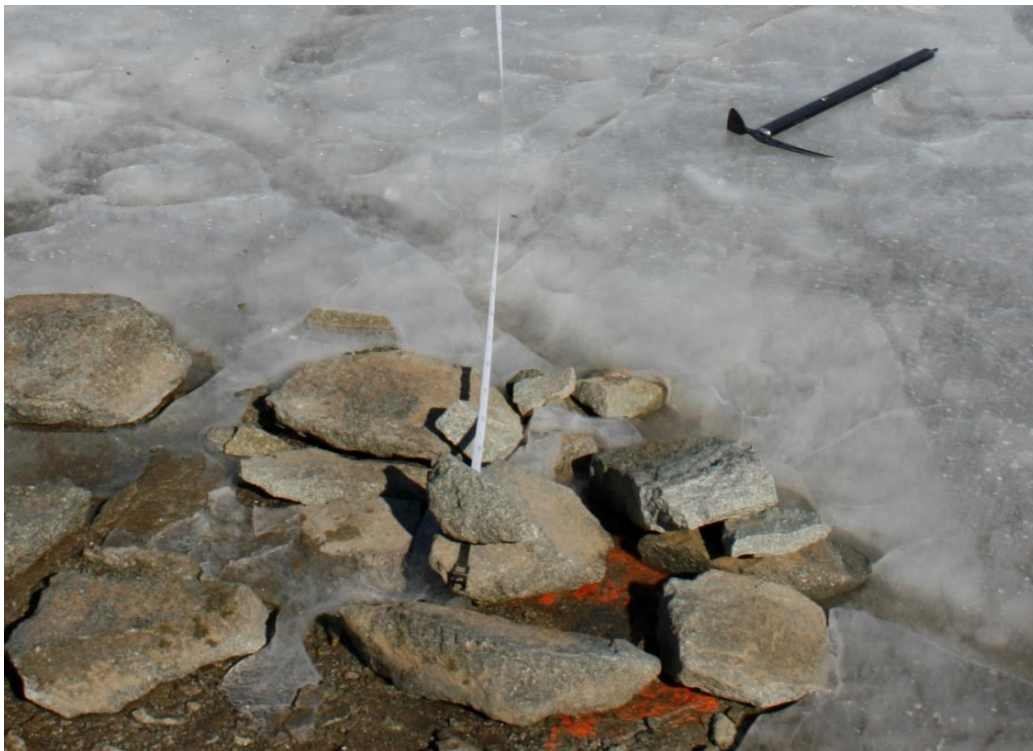
Figure 7b - Painted marker rock on the edge of Lake Vanda at the site of the former main helicopter pad, near sampling site HP21.

The opportunity still exists to remediate the remaining contaminated soil at the former site of Vanda Station. The removal of visible rubbish from the soil and extraction of diesel-contaminated soil would reduce the risk of localised environmental effects on the lake water. This should include removing the orange-painted marker rocks, including those now residing at the Vanda Huts helicopter pad.

Sites HP21-23 were located on the old main helicopter pad, which has experienced recent and shallow flooding. These sites were easy to locate accurately from an orange painted marker rock on the north eastern edge of the old helicopter pad. The additional site HP5 was chosen to represent the old lower helicopter pad, but the exact location of the 1996/7 HP5 site was difficult to determine, so there is uncertainty in this location.

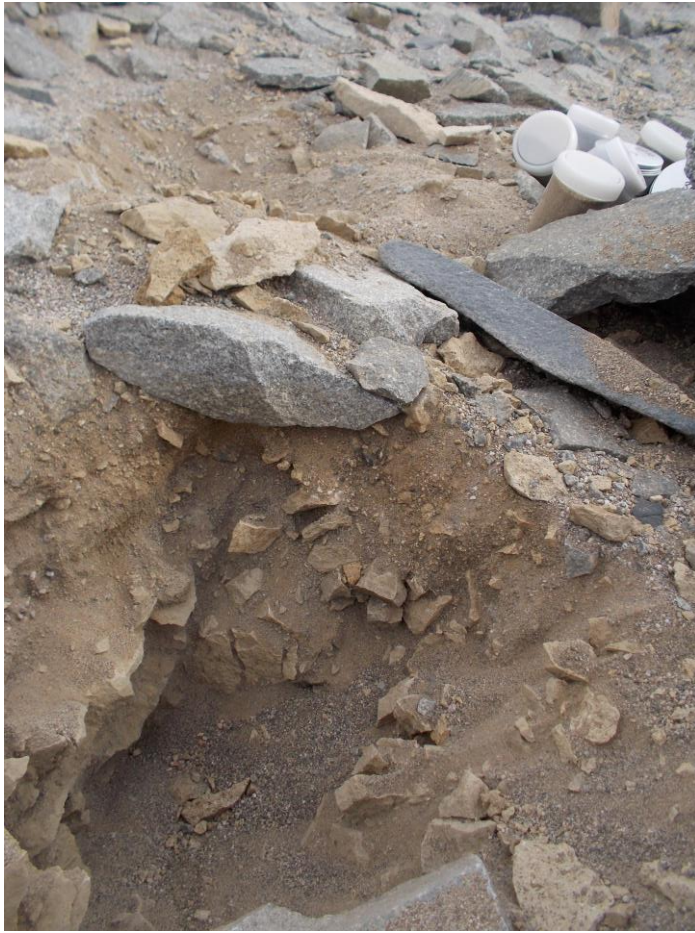
Figure 8. Hydrocarbon staining of soil in pit at site HP 10

Elevated total petroleum hydrocarbon (TPH) concentrations were recorded only at HP10 and HP20, sites which were located due to the faint smell of hydrocarbons (Table 1b) or staining of the soil (Figure 8). Because such fuel contamination tends to be localised at the site of discharge, and such sites can be hard to find if there is no surface expression, it is very likely that there are more hydrocarbon-rich sites around the old base which have gone undetected. At HP 10, elevated hydrocarbons occur principally near the surface, but at HP 20 the TPH contamination is high throughout the profile.

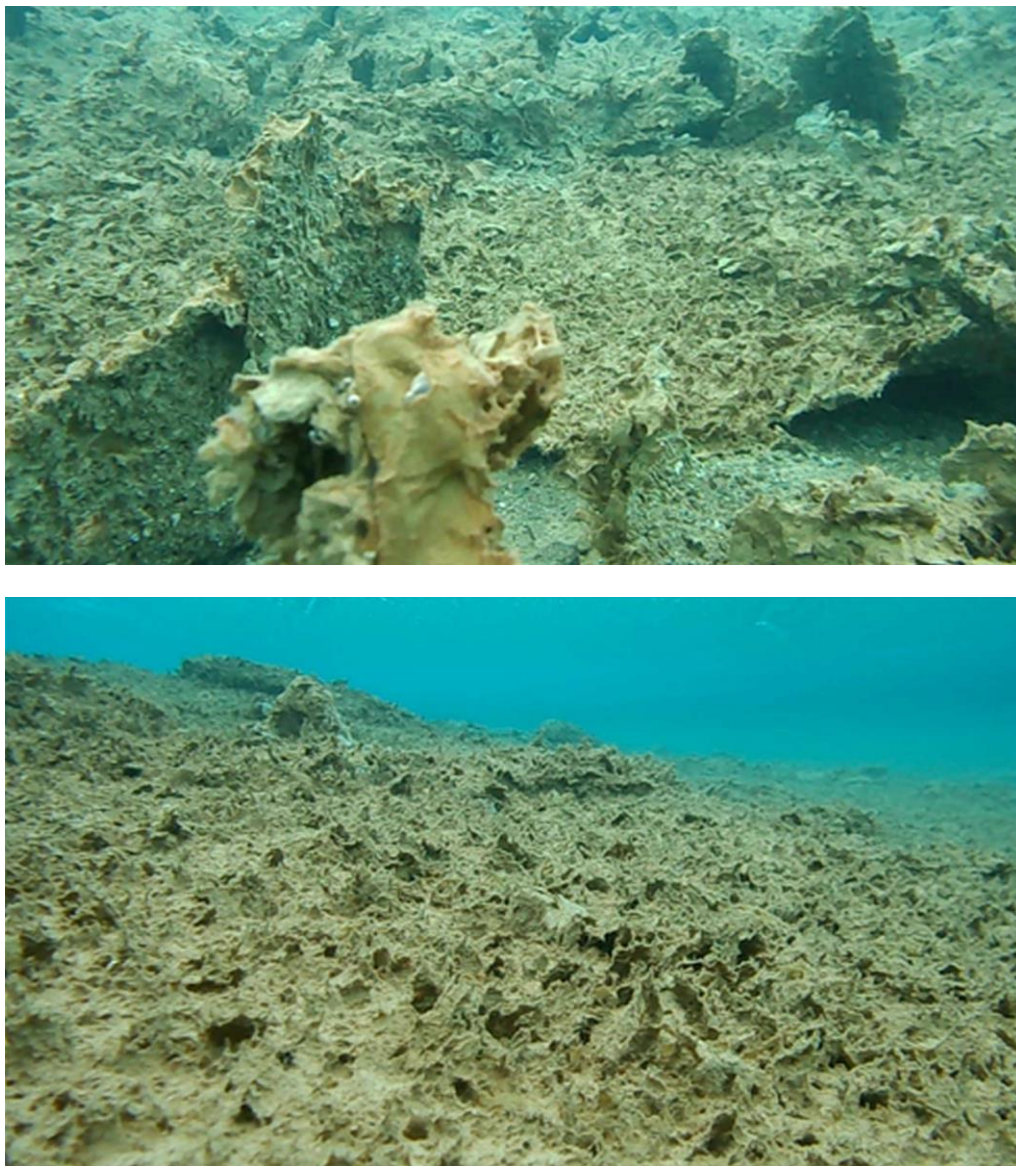
Images captured by lowering a waterproof digital camera through sampling holes GWG0 (open lake) and GW5 (contaminated gully) showed a broadly similar tan coloured mat, lifting away from the sediment in places (Figure 9). The mat appeared thicker at GW5 which may be a consequence of the higher nutrient concentrations available in the sediments and base water of the gully. It may also be affected by other factors such as light conditions. GW5 mat also had more lift-off areas, likely to reflect the higher degree of oversaturation of oxygen in the GW5 location (refer DO concentrations shown in Table 3a).

Figure 9. A visual comparison of mat development at GW 5 (top) and GW 0 (bottom).

There appears to be little difference in the composition of microbial mats in Greywater Gully compared to those at the control site VBG. The mats observed to be growing in Greywater Gully were thick and more voluminous compared to those outside of the Gully, possibly reflecting greater nutrient availability from contaminated sediments or possibly different light conditions.

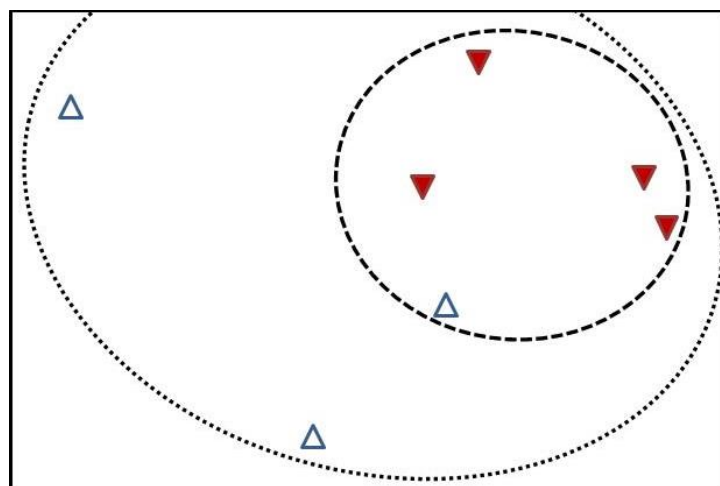
Figure 10. Multidimensional scaling plot based on fourth-root transformed OTU frequencies for all bacteria. Open triangles are VBG (control) sites, closed inverted triangles are GW5 (impacted) sites. The dashed line encloses samples that are 50% similar, the dotted line 40% similar.

Richness, evenness and diversity indices for the seven samples were similar (Table 7), and MDS based on all bacteria grouped all samples within a 40% similarity envelope, though there was a tendency for the GW5 samples to group together (Figure 10). When only the cyanobacterial data were used for MDS analysis, no grouping was observed (MDS not shown) and no consistent differences between the sites were observed (Figure 11). No taxa were unique to one site, and all of the taxa that were recognised are common across the McMurdo Dry Valleys. Species of *Leptolyngbya*, *Phormidium* and *Nostoc* are consistent mat dominants in many shallow water habitats in the Wright and Taylor Valleys.

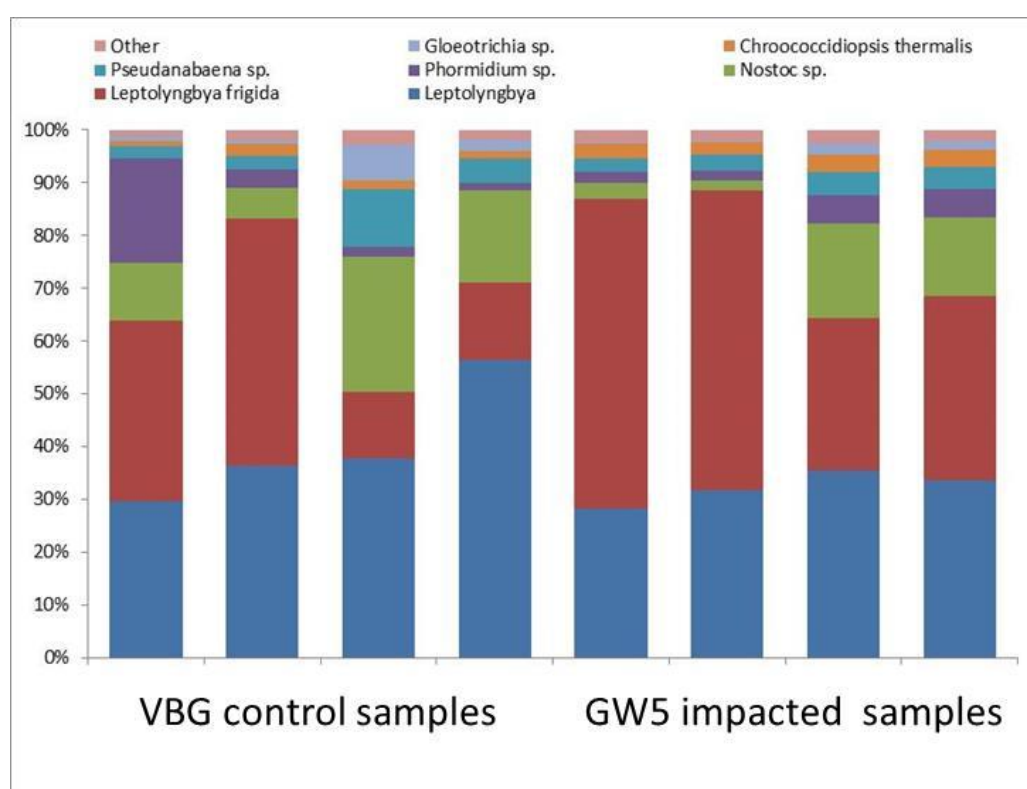
Figure 11. Relative abundance of cyanobacterial groups in the samples from VBG and from GW5.
