**UC Campus Waterways Health Monitoring:
A Preliminary Design for an Integrated Monitoring
Programme**

Summer Scholarship Report

WCFM Report 2018-003

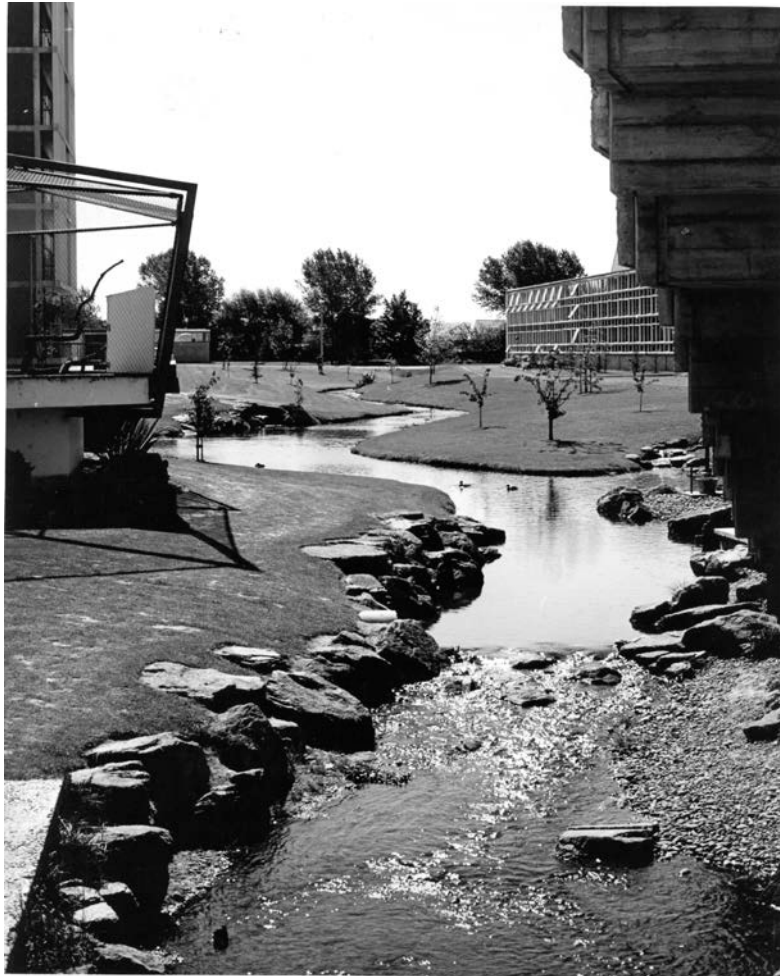
Figure 1. Okeover Stream near the Engineering Block, showing bare stream banks and a few deciduous exotic trees (Photo dated 7/11/69 by David Jones, Geology Department)

During its development, the current University of Canterbury campus was mostly planted with grasses and exotic trees, as can be seen in Figure 1. Increasing impermeable surfaces from construction, alongside maintenance methods that involved the removal of all riparian margins, led to sedimentation issues and the accumulation of various contaminants. This in turn resulted in a gradual decline in both water quality and biodiversity (O'Brien, Barker, & Weston, 1998). While the stream flow may have been supplemented by a range of artificial inputs, including run-off from carparks, the resulting flows were of a much reduced quality (Sustainability Office, 2015).

Restoration of University of Canterbury waterways began in 1997 and grew into a collaboration between the Christchurch City Council and Kakariki (the University of Canterbury student environment group), focussing almost entirely on Okeover Stream (O'Brien et al., 1998) as shown prior to restoration in Figure 1. Between 1998 and 2005, a

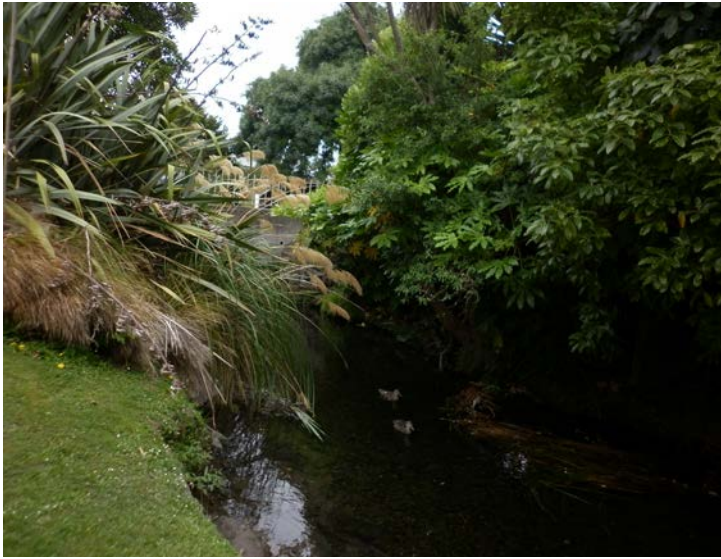
Site A1: 13m downstream of Waimari Road

8m upstream of Waimari Village runoff

Easy access

-43.52421, 172.57348

Figure 3a Monitoring sites located along the Avon River. GPS coordinates are accurate to approximately 5m.

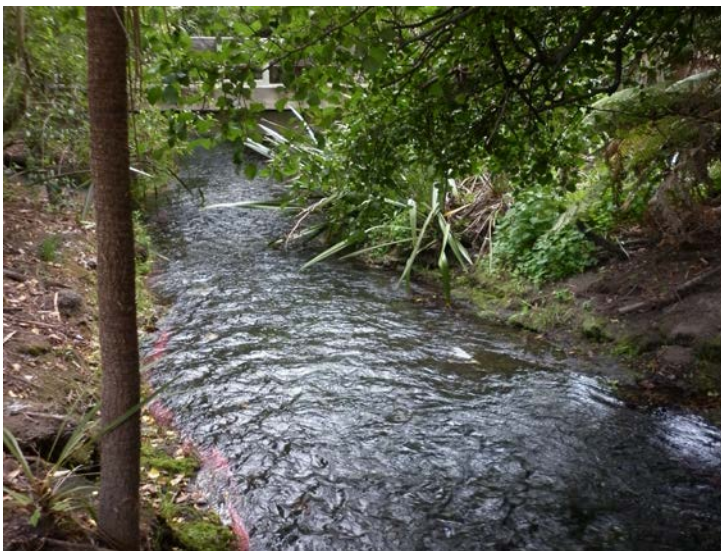
Site A2: 10m upstream of UCSA Bridge

Road runoff about 8m upstream

Easy access

-43.52404, 172.58124

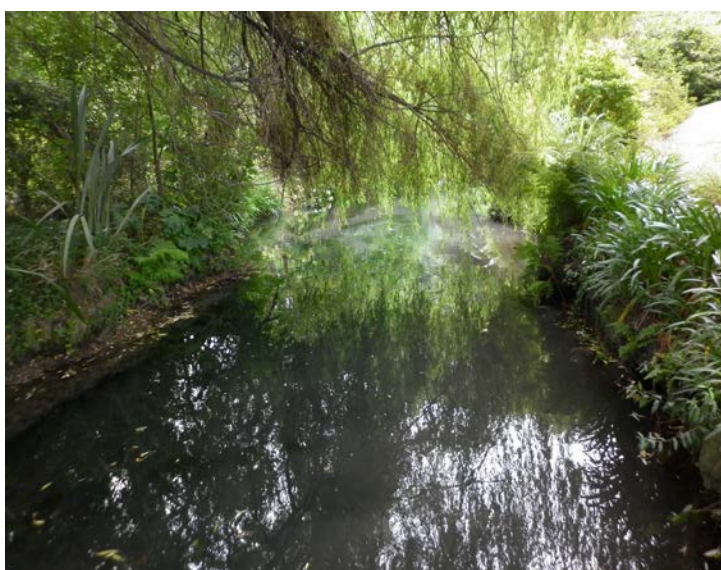
Site A3: 8m upstream of Clyde Road

Permanent water level marker

-43.52671, 172.58698

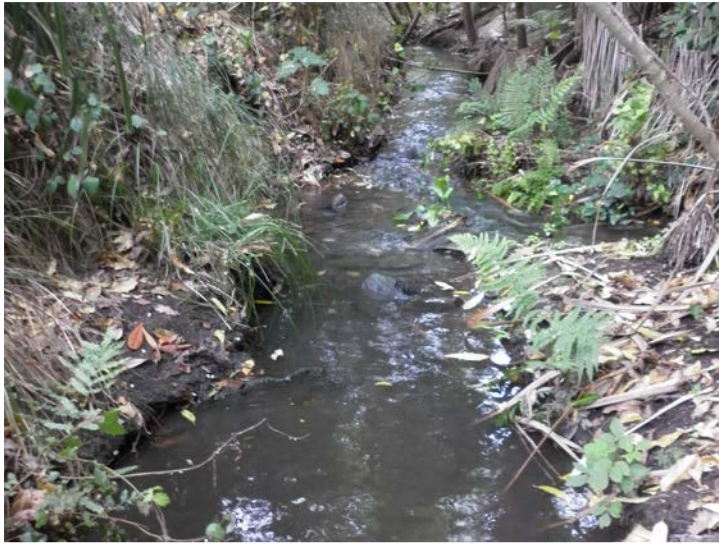
Site O1: 12m downstream of the Crèche Bridge, below Ilam Road

3m upstream of first cooling water input

Relatively difficult access

-43.52143, 172.57988

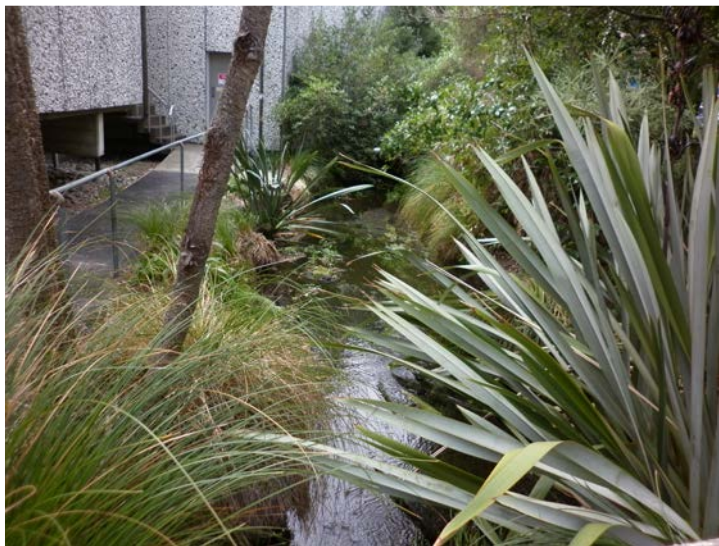
Site O2: at Engineering Bridge

Permanent water level marker

Easy access

-43.52189, 172.58327

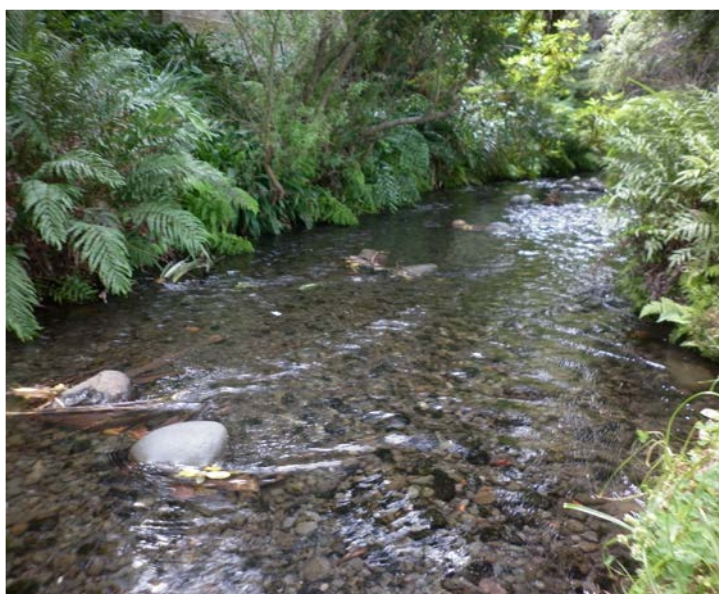
Site O3: behind second collection of glasshouses

No permanent water level marker
